# Manhole Inspection Summary

Manhole # S39EE\_031MH

Insp Date: **1/9/08 1:25 PM**

**Location** Address: **1101 E CHASE ST**

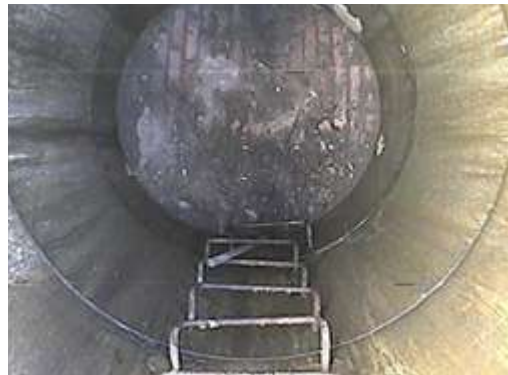
Defect 2

Count: **7** Missing: **0** ☒ **Corroded**

evidence surcharge and corroded step

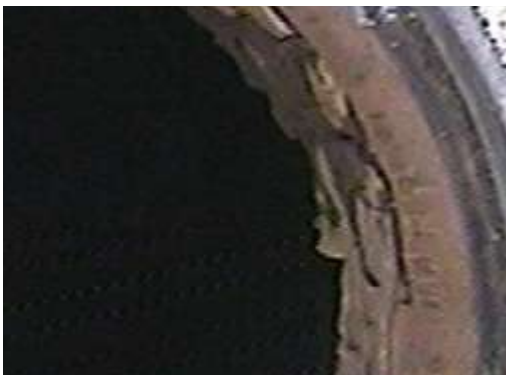
Defect 1

Condition: ☐ Sound ☐ Cracked ☐ Root Intrusion ☒ **Loose Brick** ☐ Deteriorated

loose bricks chimney
